RESEARCH MEMORANDUM

EXPLORATORY ENGINE TEST OF TRANSPIRATION-COOLED

TURBINE-ROTOR BLADE WITH WIRE-CLOTH SHELL

January 20, 1954 Declassified December 3, 1958

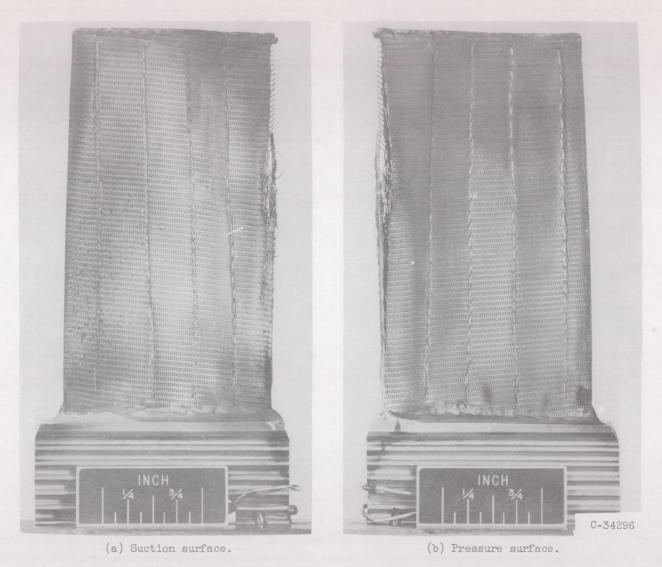
Figure 8. - Blade 1 after subjection to engine test.

Visual inspection of the transpiration-cooled blades after engine operation at 11,500 rpm and an effective gas temperature of 1350° F showed that part of the wire cloth on the trailing edge of the tip region had been severed from the rest of the blade (fig. 8). When metal discoloration was used as an indication of maximum operating temperature, the wire-cloth shell did not appear greatly overheated in other regions. The pressure surfaces of both shells were hotter than the suction surfaces, as may be noted by the discoloration patterns shown in figures 8(b) and 9(b). Somewhat higher temperatures at the junction of the wire cloth and the strut than in the porous regions were also indicated. No evidence was apparent, however, of any separation in the band between the shell and the fins on the strut.

The damage in the trailing-edge region was probably due to the fabrication methods. It is possible that the welding necessary to join the wire cloth may have induced brittleness in the wires in the neighborhood of the weld, so that some caution should be exercised in design and fabrication of this region. Perhaps the lack of sufficient rigidity could be alleviated by a shorter span from the strut support to the trailing edge of the shell.

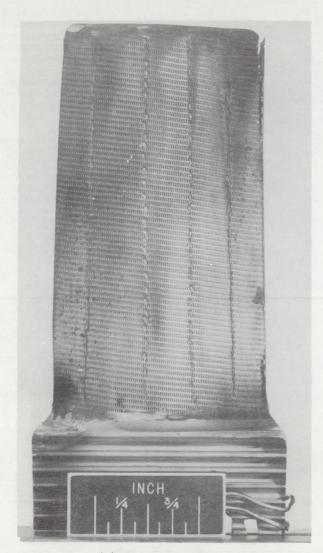
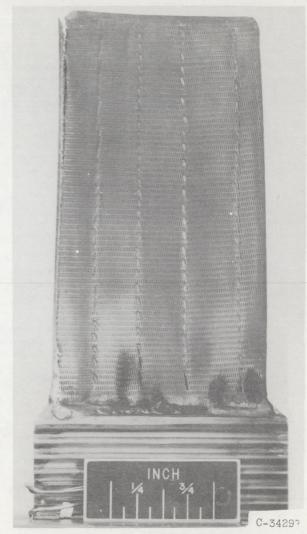
Figure 9. - Blade 2 after subjection to engine test.

Although there are definite indications of spanwise variations in shell temperature, the orifices in the base of the strut seemed to provide satisfactory coolant distribution to minimize chordwise temperature variations (figs. 7(a), 8(a), and 9(a)).
